Full Scale Fire test on a Post Tensioned Slab

Reinforced concrete structures in fire: a review of current rules

By Dr. Fergal Kelly

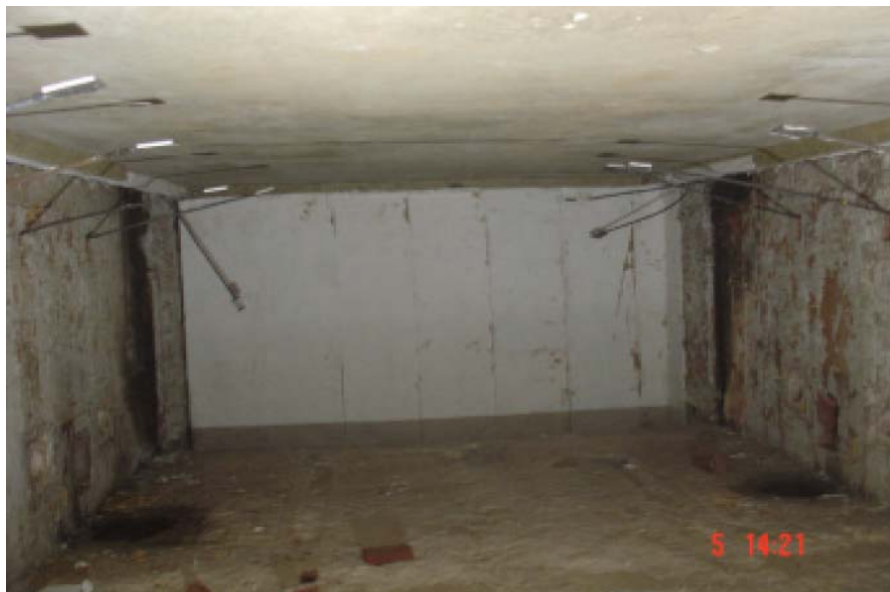
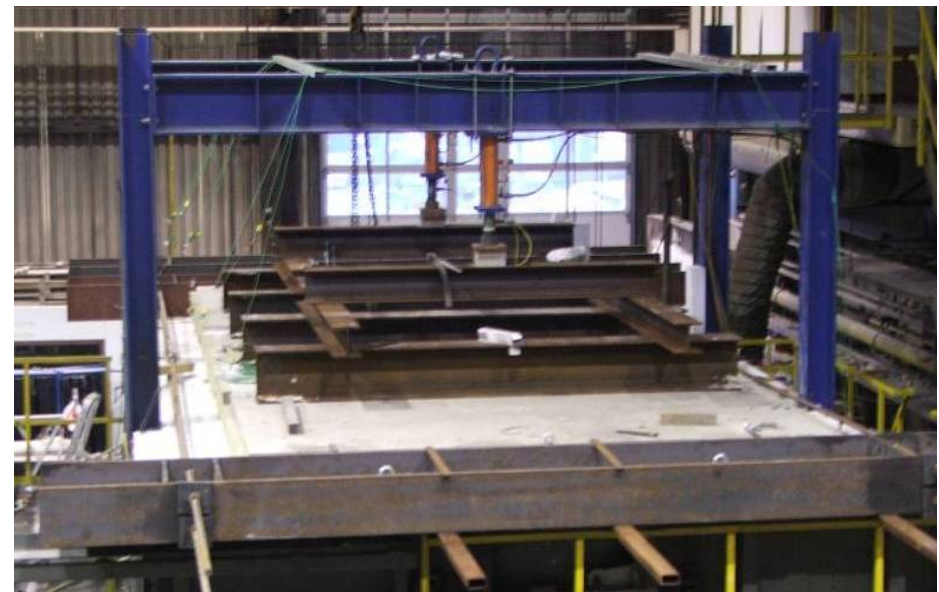
■ Test Configuration

- Standard fire test temperature curve
- 20 type K thermocouples, plate (control) and wire
- Restrained test, 1200 kN force, 10% preset
- Twin hydraulic rams with spreader beams
- Deflection via 3 LVDT gauges at mid-span
- Load ratio of 0.5

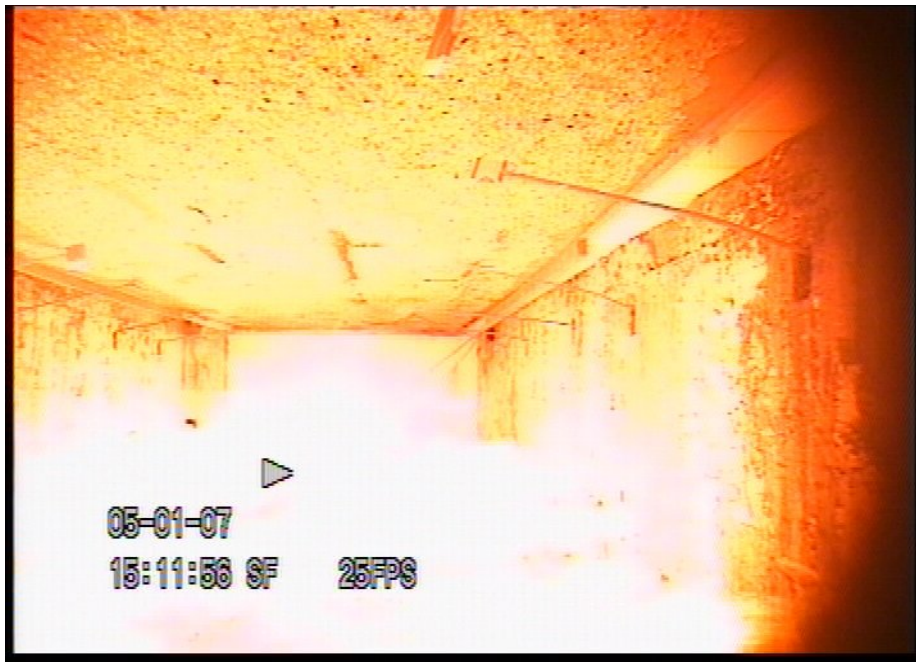
■ Summary

- 11 mins - Spalling began
- 18.5 mins - Max restraint force reached
- 20 mins - PT ducts visible
- 28 – Spalling reduces, steady increase in deflection
- 66 mins - Collapse
